AVIATION INVESTIGATION REPORT

A01H0004

LANDED BESIDE RUNWAY

AIR CANADA REGIONAL AIRLINES

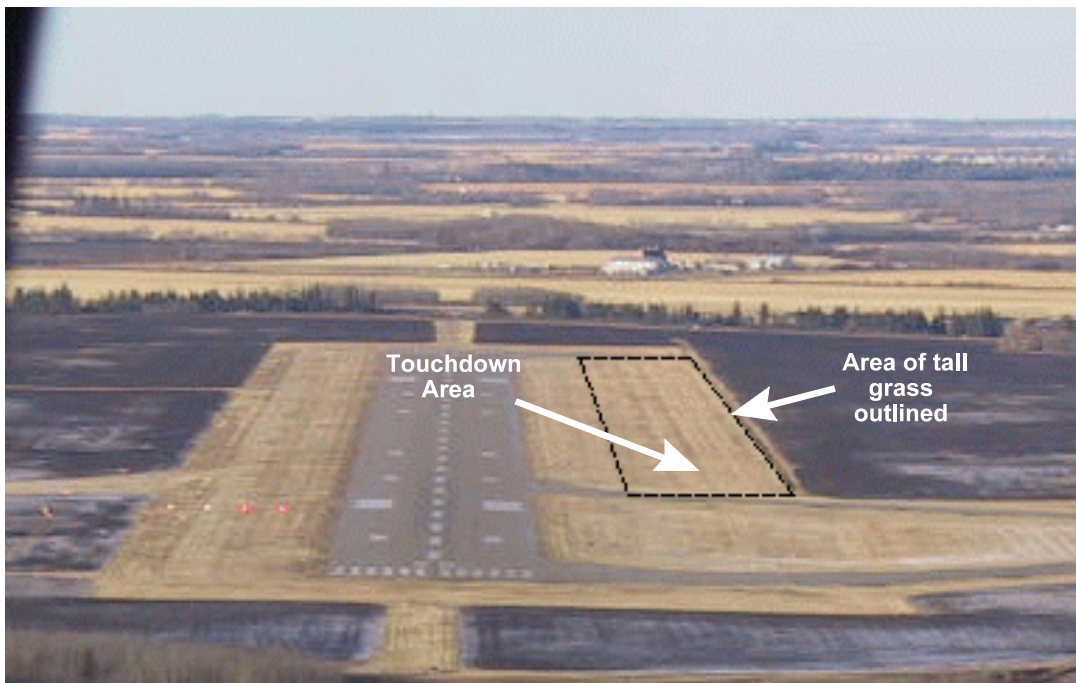
Comments concerning the runway environment were obtained from pilots who had landed on Runway 22 before and after CDR8321. The first officer of a flight that landed at 0747 that morning recalled only that the runway had some snow on it. The first officer of a flight that landed at 1032, after the 20-foot wide swath had been cleared down the centre of the runway, commented that the cleared area made the runway look very obvious, and that without it, it would not be hard to mistake the grass area for the runway.

Figure 1 – Landing area, after the snow had melted

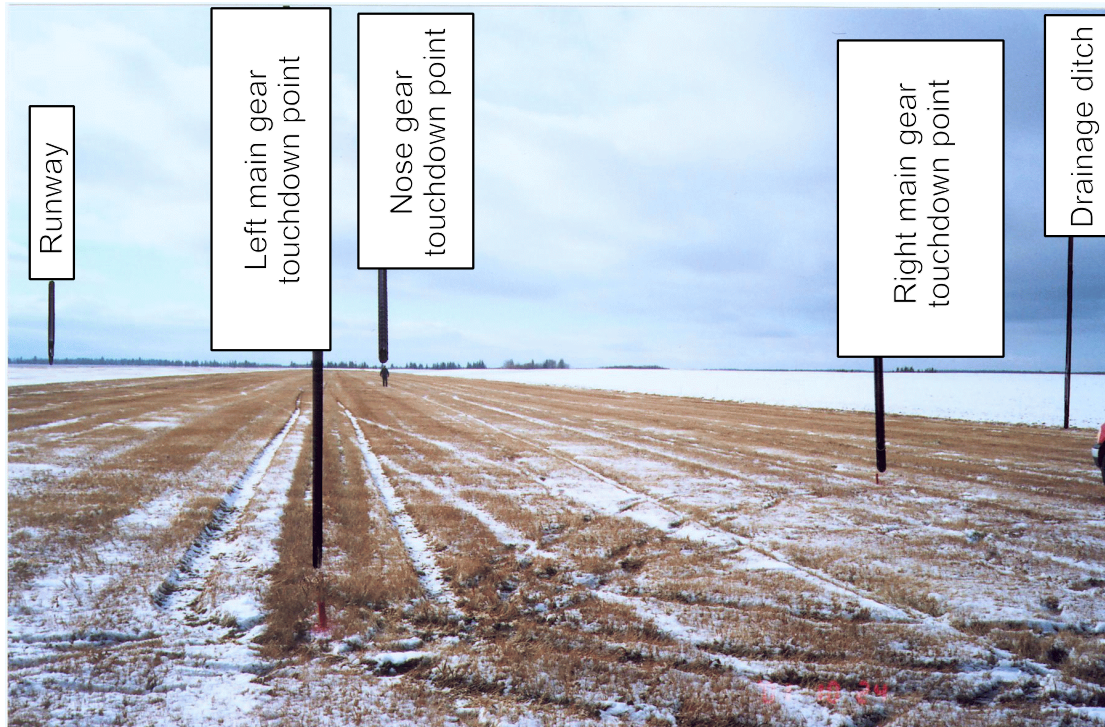
The day before the occurrence, the grass around the perimeter of Runway 04/22 was being cut when it started to snow, and the airport maintenance worker did not finish. The grass around the runway perimeter had been cut except for a strip about 150 feet wide and about 4000 feet long beside and parallel to the runway. Runway 04/22 is asphalt surfaced and is 150 feet wide and 5000 feet long. The grass that had been cut was about five centimetres long and the uncut grass was about 15 centimetres long. At the time of the occurrence, snow had accumulated to a depth of about three centimetres. The short grass was covered with snow but the long grass protruded through the snow. The protruding grass was light brown in colour. The uncut grassy strip contained some tracks from ground vehicles. A wind sock was near the middle of the far end of the grassy strip and the PAPI lights for Runway 04 were just beside the far end.

Figure 2 – Touchdown area, before the snow had melted

5. A strip of uncut grass, similar in colour and size to the intended runway, protruded above the snow in an area beside the runway. The flight crew mistook the grassy area for the runway and landed on it.
6. There were no compelling cues, such as those that could have been provided by RILS or ODALS, to alert the flight crew that they were not landing on Runway 22, which contributed to them landing off the intended runway.
